Hydro-geomorphic response to the June 19-21, 2013 storm in Canmore and the Municipal District of Bighorn, Alberta

Matthias Jakob, Hamish Weatherly, Ashley Perkins and Stephanie Bale

BGC Engineering Inc, Vancouver, B.C., Canada

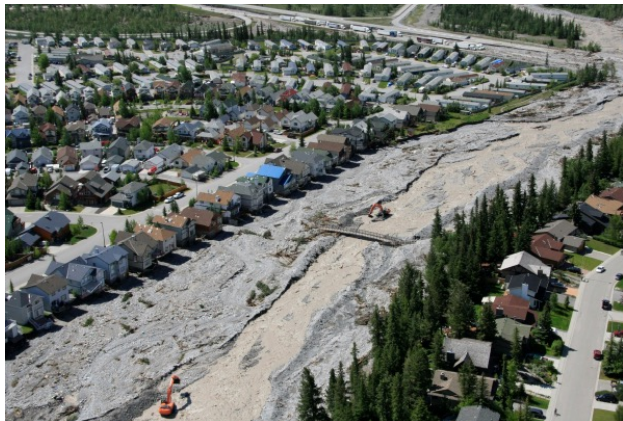
The June 2013 storm event led to extensive aggradation along Cougar Creek both upstream of the fan apex and on the fan reaches, which was accompanied by lateral instability on the fan as the channel lost confinement. Comparison of 2009 and 2013 LiDAR surveys indicates that local aggradation and erosion of up to 8 m and 5 m occurred. The channel aggradation allowed the streamflow to overtop the confines of the previously confined channel which led to flood waters eroding banks past property lines, undermining buildings foundations and destroying the support of decks and supported balconies (Figure 6). The peak flow of the debris flood appeared to have exceeded at least three to four times the estimated 100-year return period flood of 16 m³/s (AMEC, 2003). The flood event was unusual in that high flows were sustained for a period of several days.

Figure 6. Aerial view of Cougar Creek fan following the June 2013 flood.

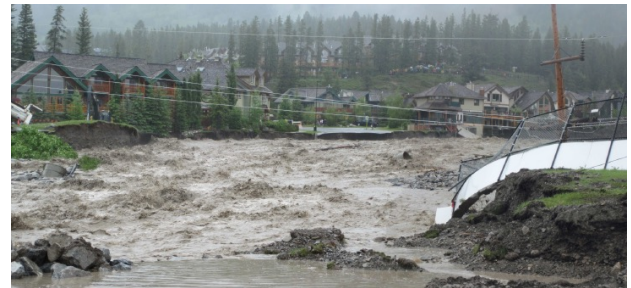
Above Elk Run Boulevard, aggradation and channel widening resulted in the creek eroding a section of road and the backyards of a number of homes. An outdoor hockey rink on the left bank of the creek at Elk Run Boulevard was also completely destroyed (Figure 7). A major concern during the flood was Elk Run Boulevard becoming outflanked, resulting in the creek overtopping the road and potentially heading into the subdivision. Emergency crews were present throughout the storm at the road crossing to keep the culvert inlet as free of debris and sediment as possible and to minimize the amount of outflanking that did occur (major erosion occurred behind both concrete wingwalls). Existing riprap on either bank was completely destroyed during the flood, presumably due to initial undermining followed by channel aggradation.

Figure 7. Upstream view of Cougar Creek from Elk Run Boulevard during the June 2013 flood.

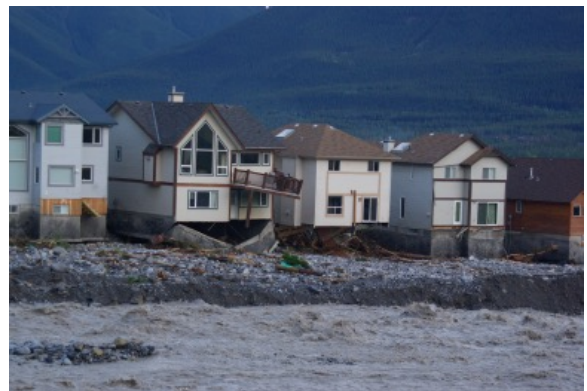
Between Elk Run Boulevard and Highway 1, the creek also significantly widened. Damages to homes were severe in this reach (Figure 8). Walking paths on either side of the creek were completely eroded and a pedestrian bridge was outflanked on either bank, although it was not washed away. Riprap placed on the banks and in the channel during 2012 was completely destroyed, initial undermining followed by channel aggradation.

Figure 8. Damage to homes along left (east) bank of Cougar Creek between Elk Run Boulevard and Highway 1.

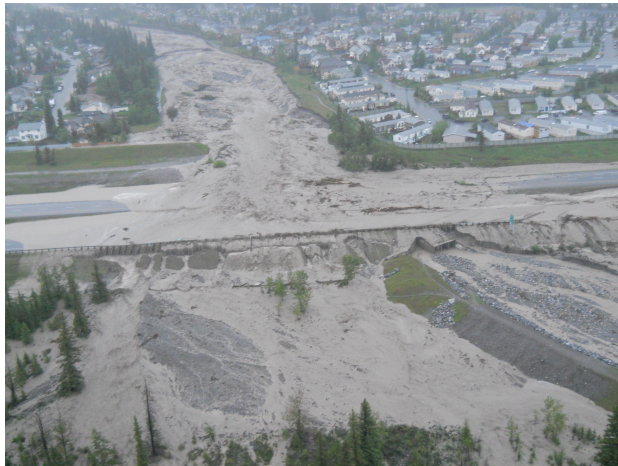
Additional major damage was recorded at Highway 1, where the blocked culverts resulted in flows avulsing over the highway and down the median to the east (Figure 9). These overflows resulted in portions of the highway being undermined and collapsing. Further downstream, the box culverts at Highway 1A and CP Rail were also blocked by sediment and debris, the latter of which was out of commission for approximately three days until it was repaired.

Figure 9. Lower Cougar Creek fan during July 19, 2013 flood. Photo: Alpine Helicopters.

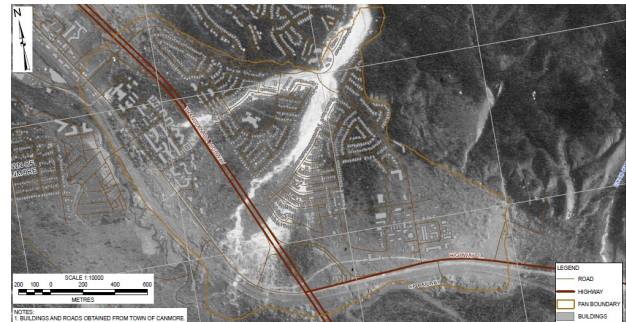
Although the June 2013 debris flood was unusual, a 1947 air photograph of the fan illustrates that the Cougar Creek fan has historically been a very active landform (Figure 10).

Figure 10. Cougar Creek current buildings and lot lines superimposed on a 1947 air photograph.

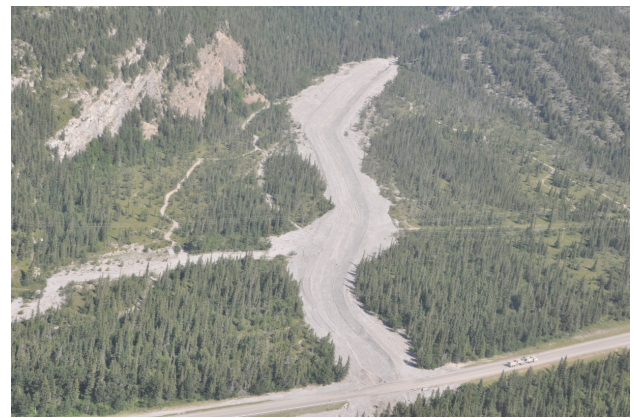
From the fan apex at elevation 1345 m, the creek flows for about 1 km down to Highway 1A (Figure 13). Prior to the June 2013 flood, streamflows used to be conveyed under the highway through a 2.2 m diameter culvert. This culvert was destroyed by the June 2013 debris flood. The CP Railway is located a further 230 m downstream, below which Jura Creek discharges into a side channel of Bow River.

Figure 13. Jura Creek fan with a re-excavated channel through the centre of the fan and the avulsion path to the left (west). Highway 1A in the foreground. July 2013.

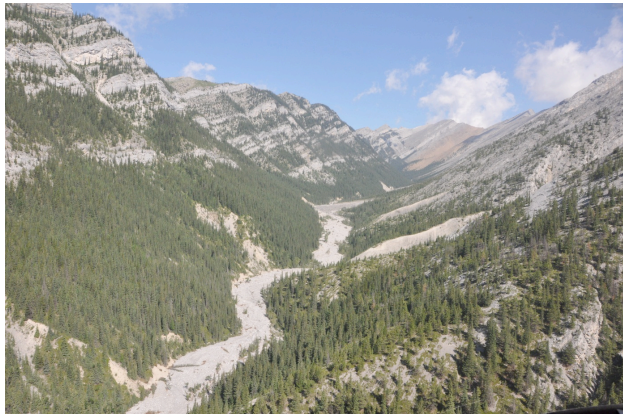
Both creeks are incised into a thick unit of presumably late Pleistocene sediments (Figure 14 and 15). These sediments are very unstable and provide a quasi-unlimited supply of sediment during flood events. The implication is that a repeat hydroclimatic event of similar magnitude to 2013 storm (or larger) will result in similar or larger sediment movements with similar or more severe flood consequences, and potential risks to personal safety.

Figure 14. Upper watershed of Jura Creek showing a very active floodplain approximately one month after the June 2013 debris flood.

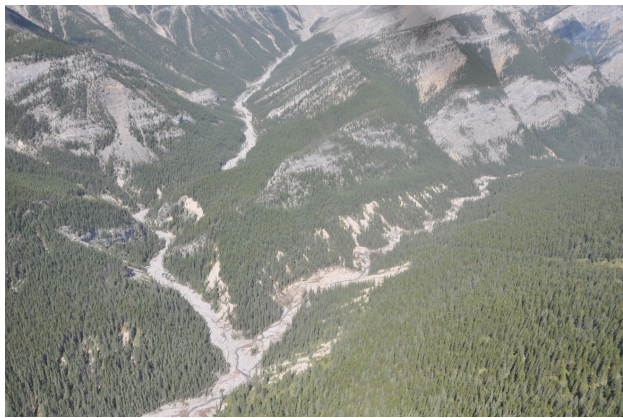
Figure 15. Upstream view of Exshaw Creek in mid reaches. The channel is incised into a thick sequence of unstable late Pleistocene sediments. July 2013.

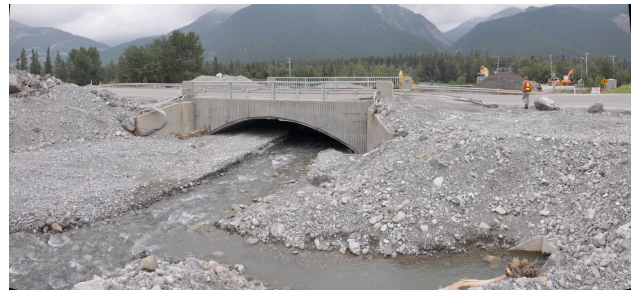
About this time the bridge at Highway 1A had become blocked with debris and a second flow avulsion developed on the left (east) bank of Exshaw Creek (Figure 16). These overflows were conveyed along the upslope ditch of Highway 1A toward the already inundated low-lying area, further aggravating flooding there.

Figure 16. Downstream view of the Highway 1A bridge spanning Exshaw Creek. July 2013.

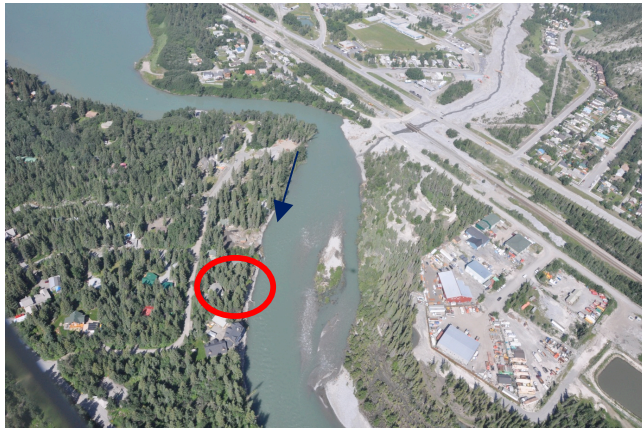
confluence with Bow River. Reeve Dene Cooper noted that the fan temporarily extended about two-thirds of the way across the river at the peak of the flood event, resulting in Bow River flows being diverted along the right (south) bank which led to significant bank erosion of the Heart Creek fan (Figure 17). One home in Lac des Arcs was severely undermined by the bank erosion. Review aerial imagery indicates that approximately 15 m of bank erosion occurred at this location during the flood event.

Figure 17. Aerial view of the confluence of Exshaw Creek with the Bow River. Deposition at the mouth of Exshaw Creek concentrated flows along the right bank of the Bow River, resulting in bank erosion and undermining of one home (circled in red). All homes of Lac des Arcs are located on Heart Creek fan.
