Hydro-geomorphic response to the June 19-21, 2013 storm in Canmore and the Municipal District of Bighorn, Alberta

Matthias Jakob, Hamish Weatherly, Ashley Perkins and Stephanie Bale

BGC Engineering Inc, Vancouver, B.C., Canada

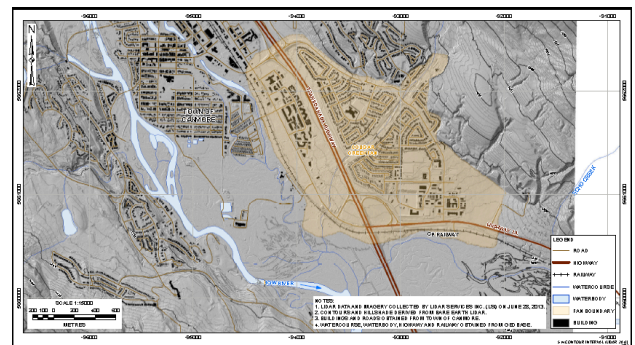
Cougar Creek fan has an area of 3.1 km² and is unlike most fans in the Canadian Rocky Mountains in that it is very densely developed, including 1417 residential homes; a number of lodges/resorts between Highway 1 and Highway 1A; a light industrial area in the southeast corner of the fan; one elementary school (Elizabeth Rummel); a heliport (Alpine Helicopter); numerous roads including a crossing of the creek at Elk Run Boulevard; Highways 1 and 1A; the Canadian Pacific (CP) Rail line; various municipal infrastructure (telecommunication lines, sewers, etc.); and powerlines (Figure 5).

Figure 5. LiDAR-generated shaded relief image of Cougar Creek fan and Infrastructure.

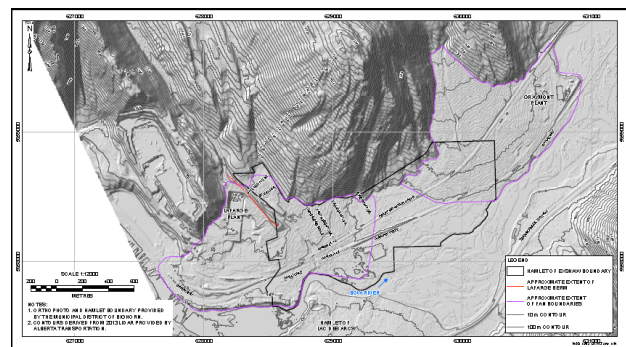
Jura Creek and Exshaw Creek are south flowing tributaries that discharge into Bow River at the Hamlet of Exshaw (Figure 11). Similar to Cougar Creek, both creeks were impacted by debris floods during the June 2013 rainstorm, with major volumes of sediment transported to their respective alluvial fans.

Figure 11. Exshaw and Jura Creek LiDAR-based topography and fan outlines.

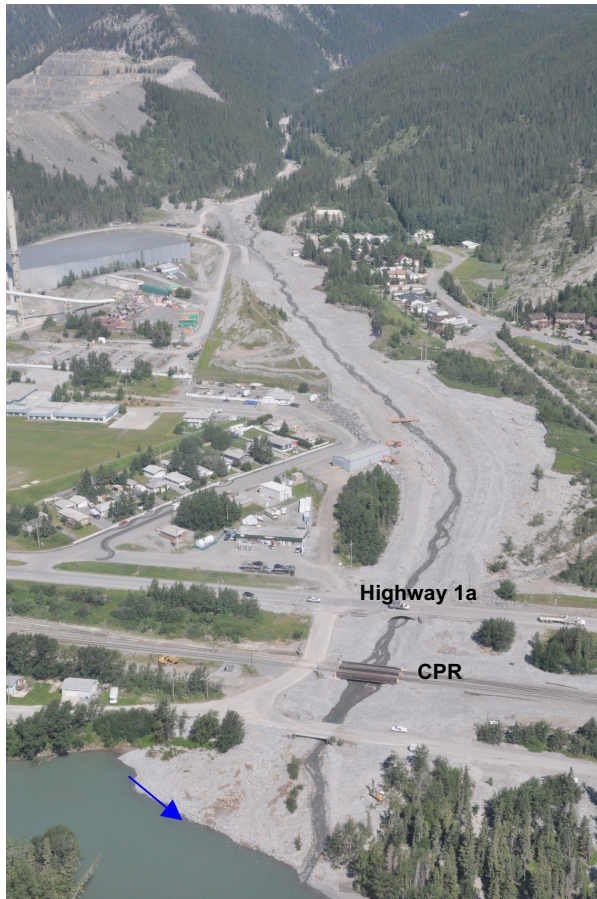
From the fan apex at elevation 1340 m, Exshaw Creek flows for about 800 m before reaching the bridge crossings of Highway 1A, the CP Railway, and a secondary road (Figure 12). Just downstream of this final bridge, Exshaw Creek discharges into Bow River. The Hamlet of Lac des Arcs is located directly opposite of Exshaw on the fan of Heart Creek, on the south side of Bow River.

Figure 12. Exshaw Creek looking upstream with Bow River in the lower left hand corner. The industrial complex on the left in mid fan is Lafarge cement. The Hamlet of Exshaw is mostly on the right (east side) of the fan.
